## **CITY COMMISSION MEETING CITY OF ST. PETE BEACH**

Tuesday, January 26, 2021  
6:00 PM

**Summary of Issue:** During the reconstruction of Pass-a-Grille Way from 1<sup>st</sup> Avenue to 19<sup>th</sup> Avenue, the soil beneath the sidewalk adjacent to the seawall was found to be eroding away. This erosion prompted a Ground Penetrating Radar (GPR) study to evaluate the extent of the subsidence. The results of this study uncovered a substantial number of voids beneath the edge of the sidewalk immediately adjacent to the seawall.

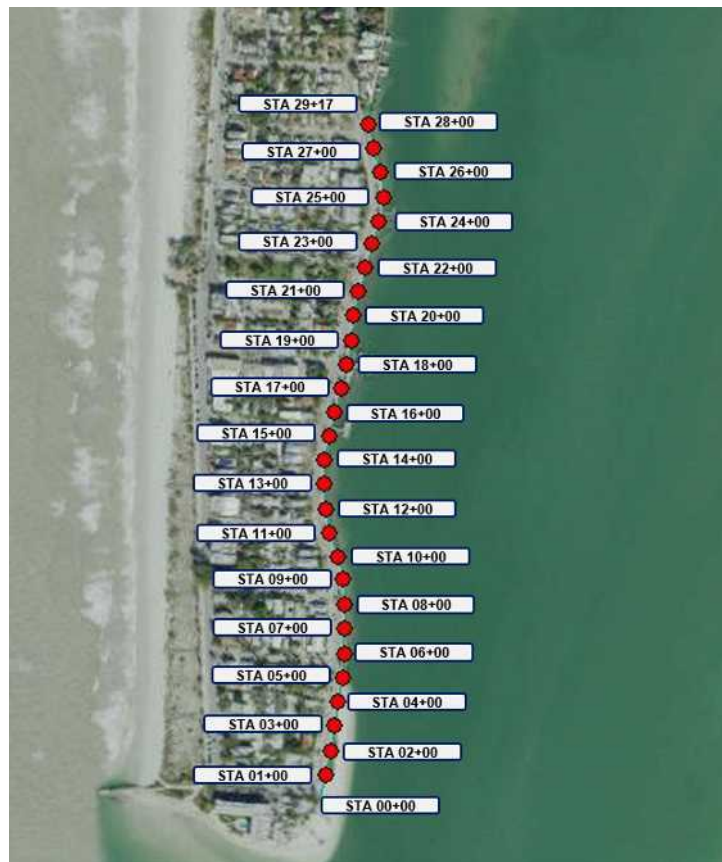
Figure 2-1 Section Layout Along the Wall

Below is a layout of the stations that were covered along the wall and a summary of the condition code rating for each section. The full inspection report is attached in Appendix A.

Cardno conducted an inspection for the existing condition of the seawall. The inspection divided the wall into 100 foot sections to group measurements and observation of the issues. Each section of the wall was then rated with an overall condition code. The inspection found out that there are intermittent transverse cracks throughout the length of the seawall. Most cracks of this variety are not significant, but there are some cracks that will require action to prevent corrosion of rebar and further concrete damage. Almost the entire cap has longitudinal cracking of some severity. Severity varies from minor to significant. Some cracks exhibit corrosion bleedout, implying underlying rebar corrosion. There are also a few instances of severe cracks beginning to spall. For most of the seawall, spalls are minor corner spalls with no exposed rebar or signs of underlying corrosion. There are also some previously repaired spalls that show signs of failure and may need to be repaired again. The shotcrete on the waterway side of the wall is delaminating throughout the length of the wall. In the relatively minor cases, the delamination occurs only around the piles. In the rarer, but more severe instances, the shotcrete surrounding both the piles and the panels is delaminating. This is exposing the joints between the panels and the welded wire fabric reinforcing the shotcrete.

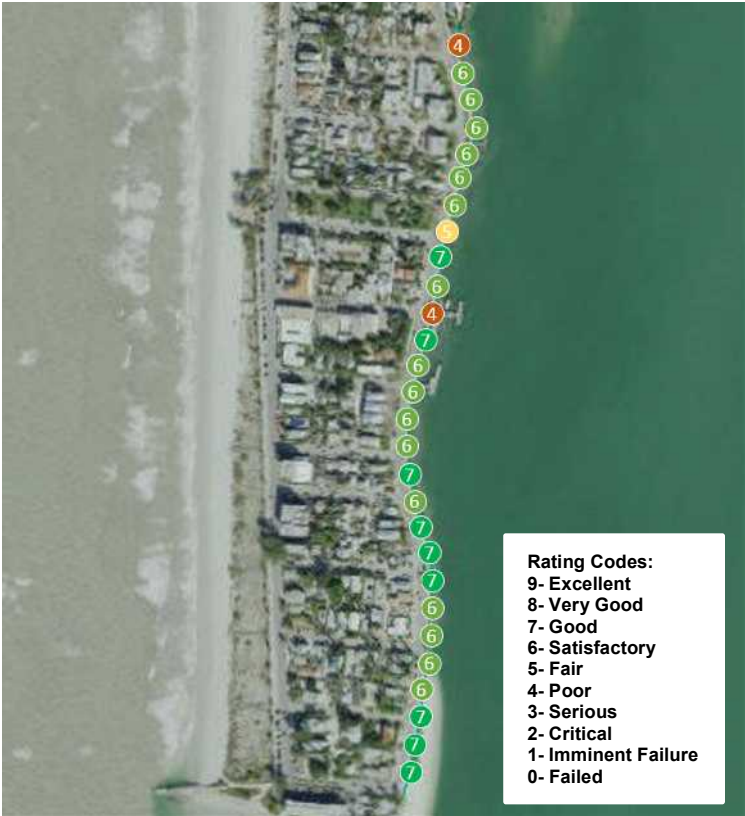
Figure 2-2 Summary of Condition Ratings for Each Section

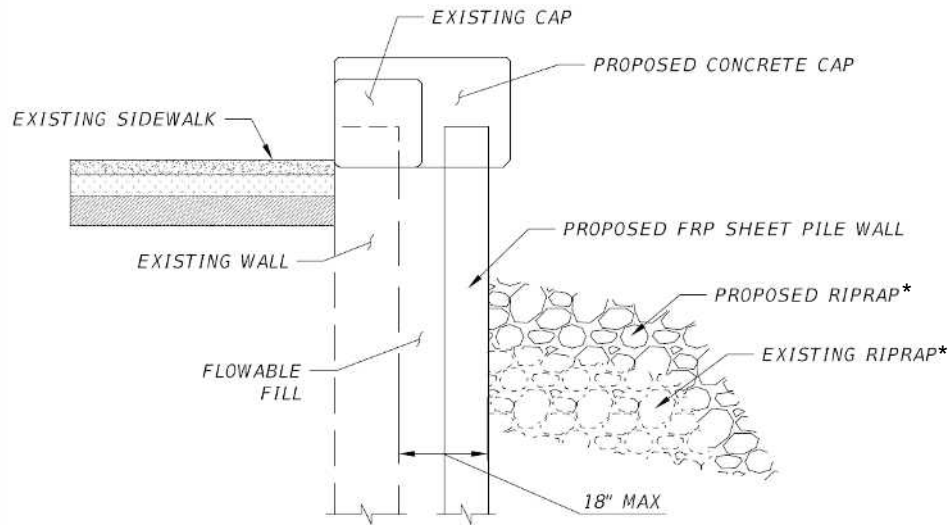
Alternative 1 consists of installing new Fiber Reinforced Polymer (FRP) sheet piles in front of the existing sheet piles, filling the void between the piles, and pouring a new cap to tie in the new wall with the old wall. This type of construction would be the most cost effective for this location and wall height. In addition, it is also recommended to inject grout below the sidewalk in order to increase the soil density and prevent future maintenance issues. The riprap in front of the wall would have to be removed to drive the sheets and then would be reinstalled and supplemented with new riprap based on the chosen environmental option. This alternative would have a high construction cost and a long design life of around 75 years.

**Figure 3-1 Alternative 1 Section**

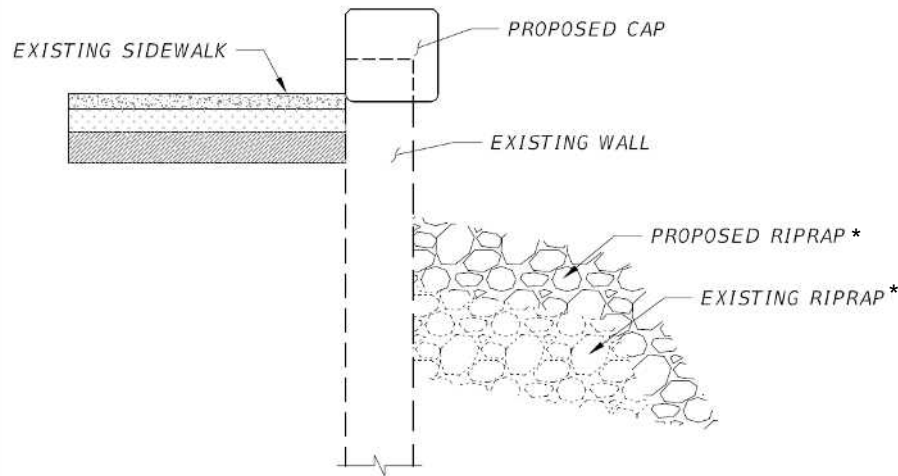
Alternative 2 consists of replacing the existing concrete cap and making repairs to the existing wall where necessary. This alternative would have a low construction cost and the design life would be approximately 15 years. The wall would likely require additional repairs during its remaining life and after 15 years, it would likely be necessary to replace the entire wall. This option would require grout injections below the sidewalk and supplemental riprap as with Alternative 1.

**Figure 3-2 Alternative 2 Section**

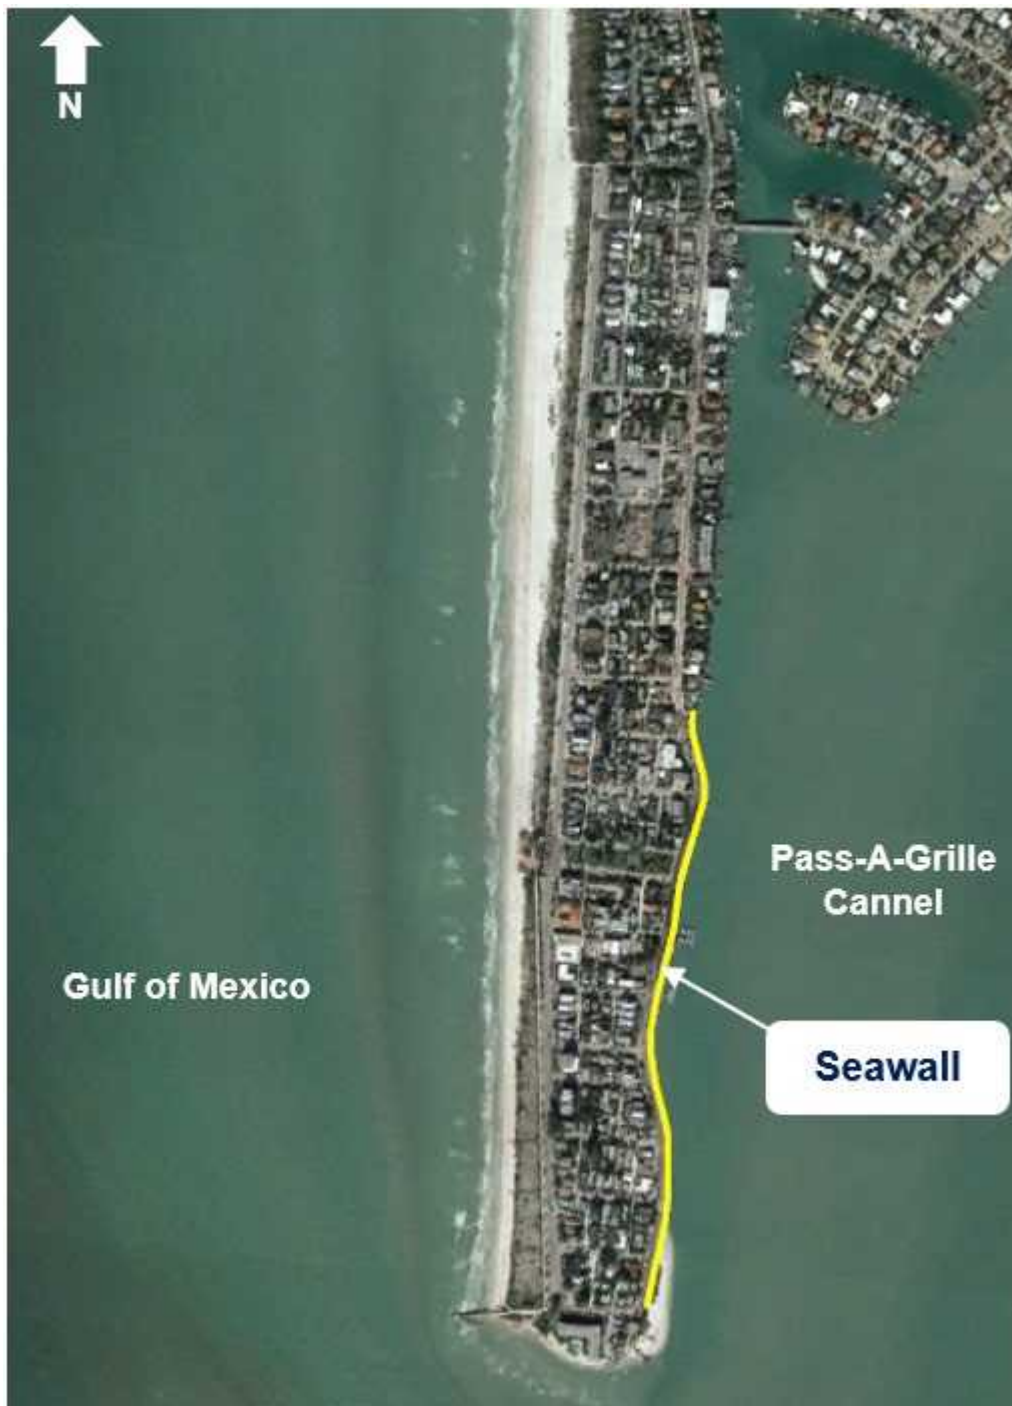
**Figure 1-1 Location Plan**

The seawall is 2917 feet in total length and was broken into increments of 100 feet for recording of the wall inspection.

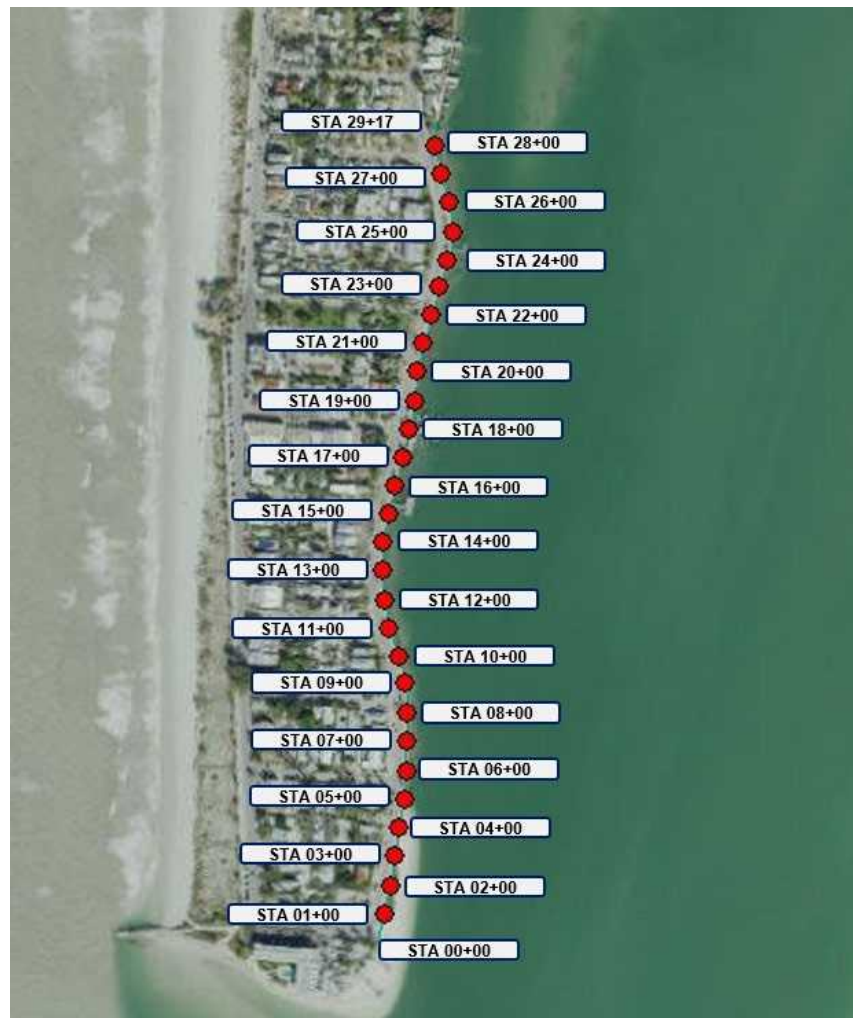
Figure 2-1 Pass-a-Grille Way Seawall Layout

Stationing was numbered starting at 0+00 from south to north. The organization of the inspection notes and photos reference the wall name and station designation for tracking purposes.

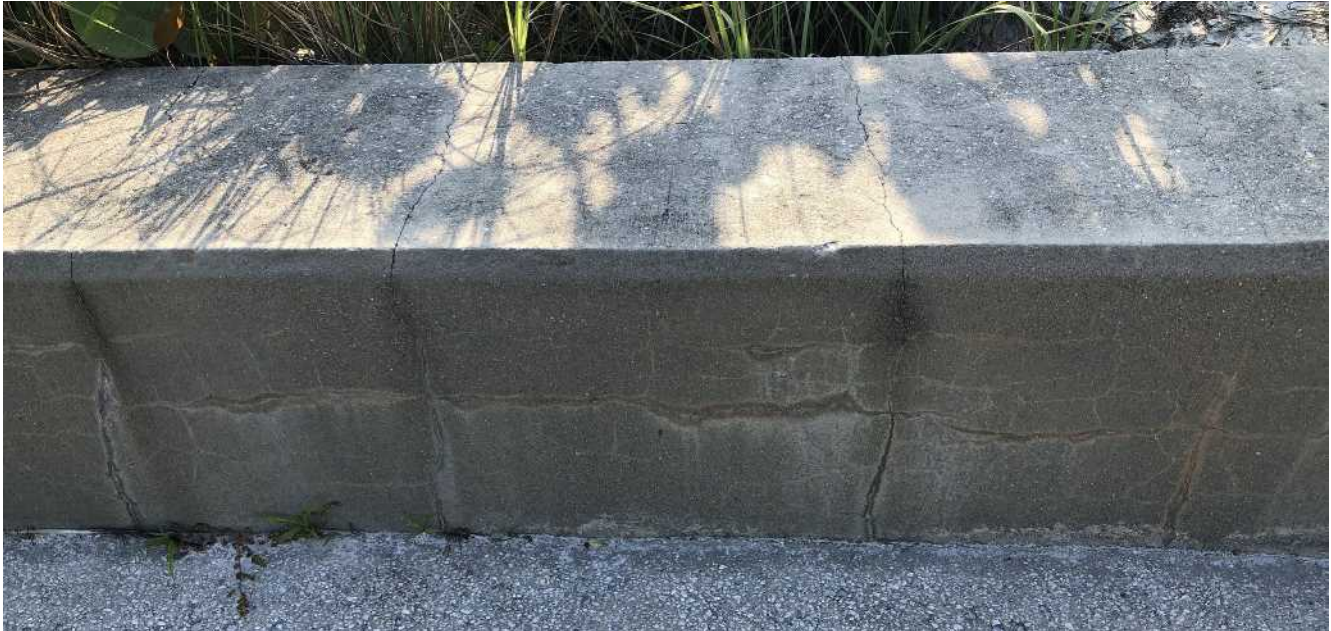
There are intermittent transverse cracks throughout the length of the seawall. Most cracks of this variety are not significant, but there are some cracks that will require action to prevent corrosion of rebar and further concrete damage.

**Figure 3-1 Typical Transverse Cracks, Station 1+00**

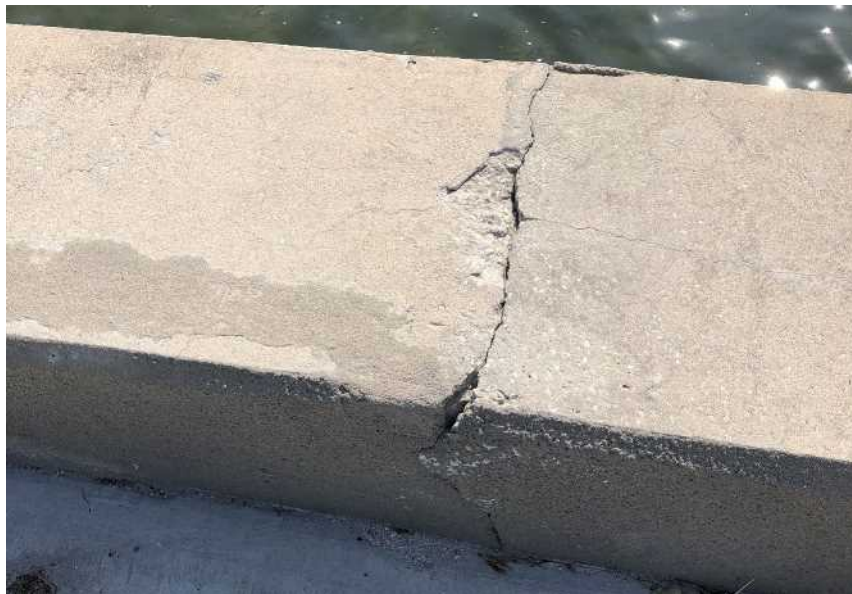
**Figure 3-2 Severe Transverse Crack, Station 15+00**

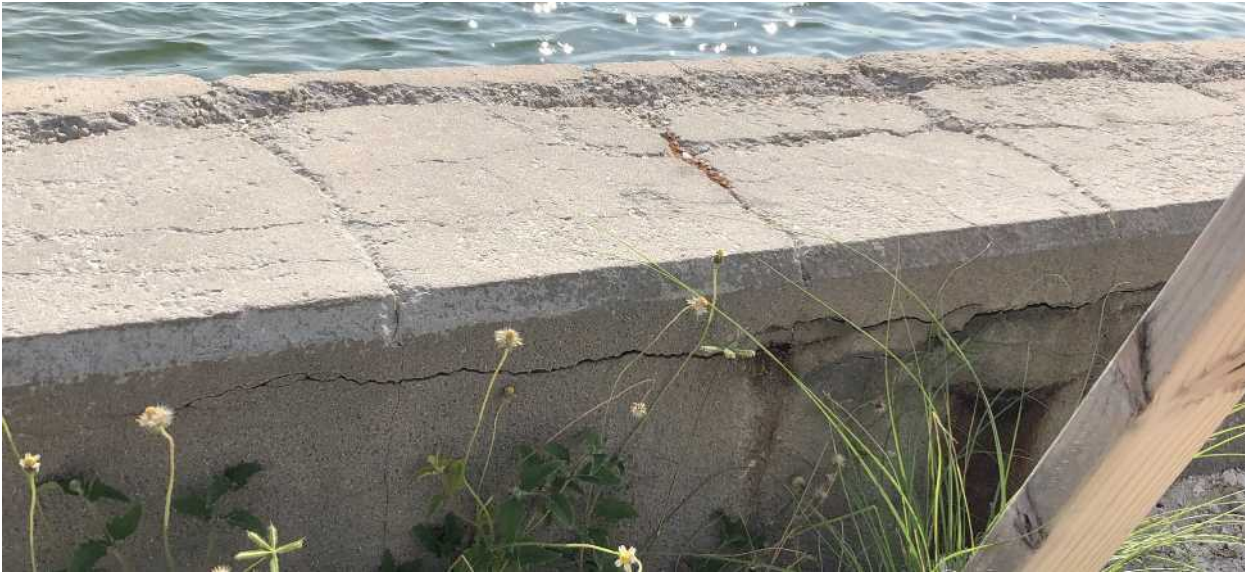
Almost the entire cap has longitudinal cracking of some severity. Severity varies from minor to significant. Some cracks exhibit corrosion bleedout, implying underlying rebar corrosion. There are also a few instances of severe cracks beginning to spall.

**Figure 3-3 Longitudinal cracks in Cap with Corrosion Bleedout**

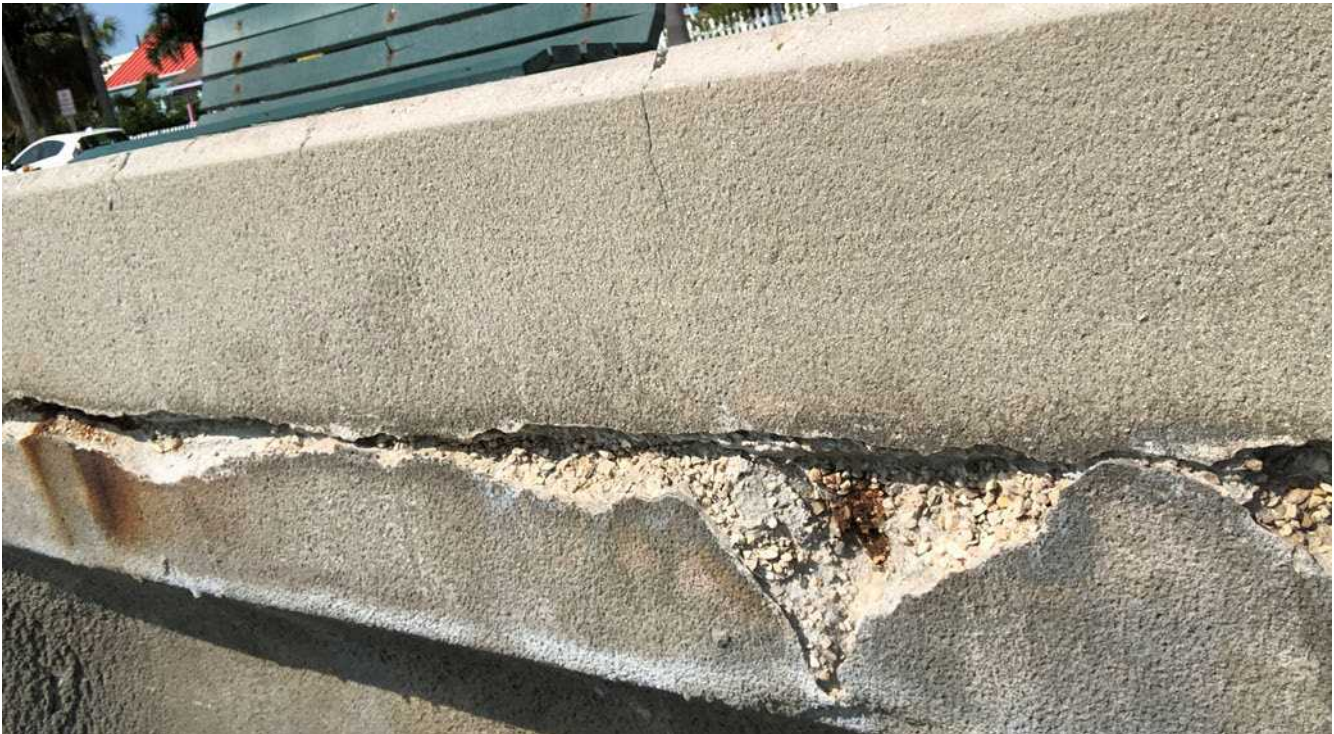
**Figure 3-4 Longitudinal Cracks with Spalling**

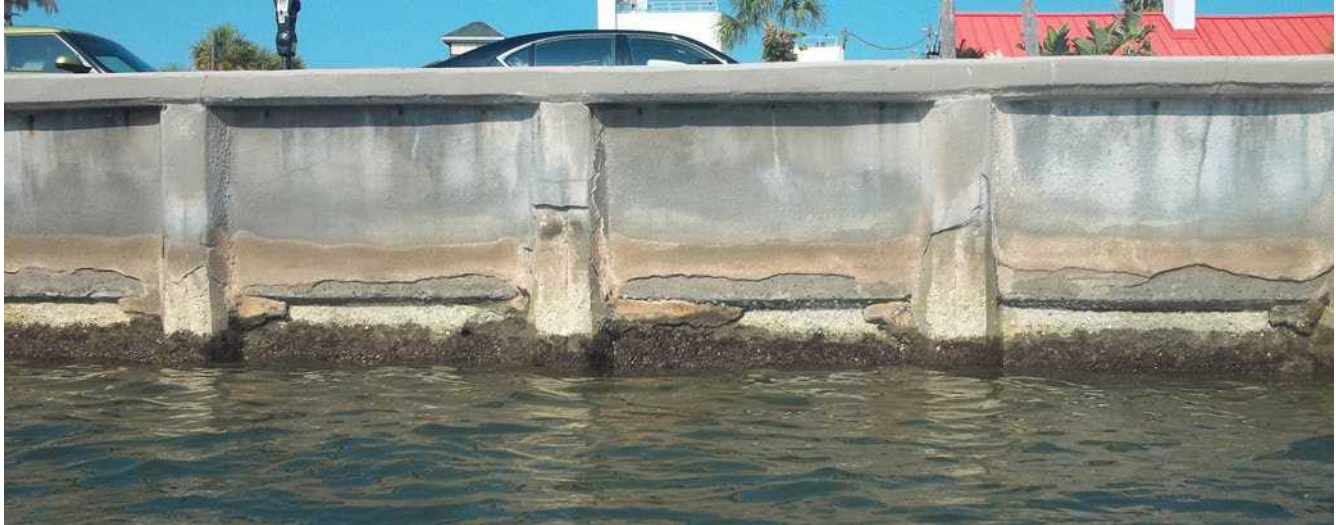
The shotcrete on the waterway side of the wall is delaminating throughout the length of the wall. In the relatively minor cases, the delamination is occurring only around the piles. In the rarer, but more severe instances, the shotcrete surrounding both the piles and the panels is delaminating. This is exposing the joints between the panels and a steel wire mesh reinforcing the shotcrete.

**Figure 3-5 Loss of Shotcrete**

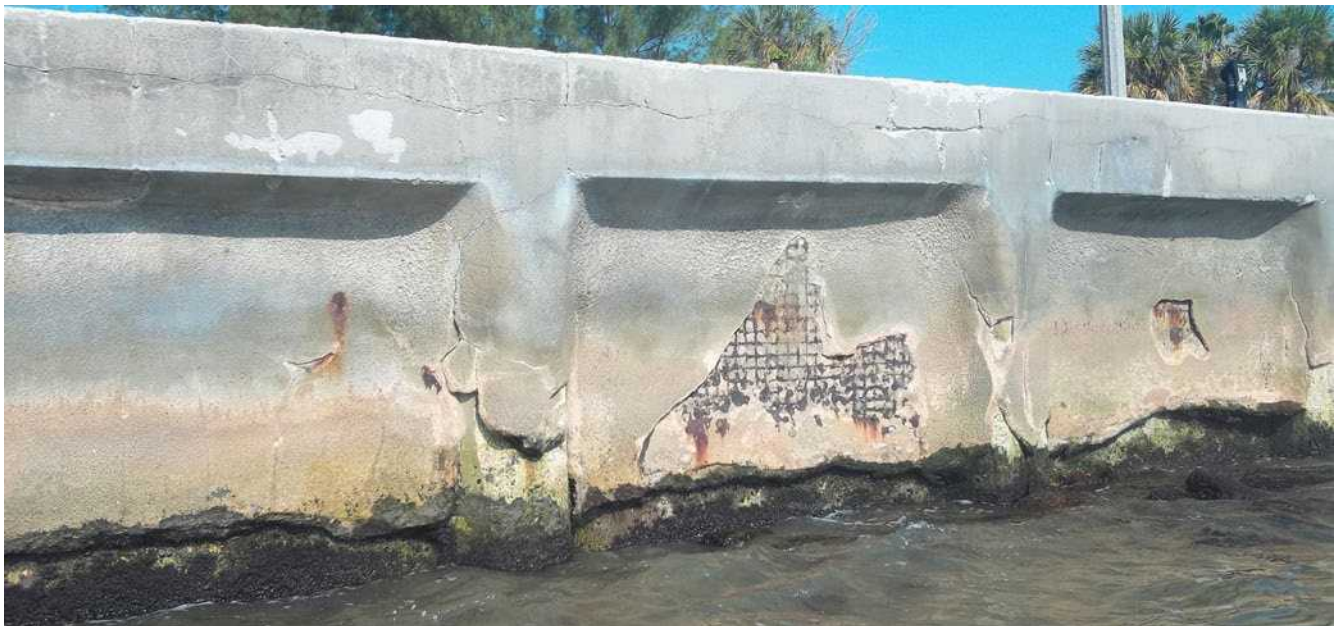
**Figure 3-6 Loss of Shotcrete Exposing Mesh**

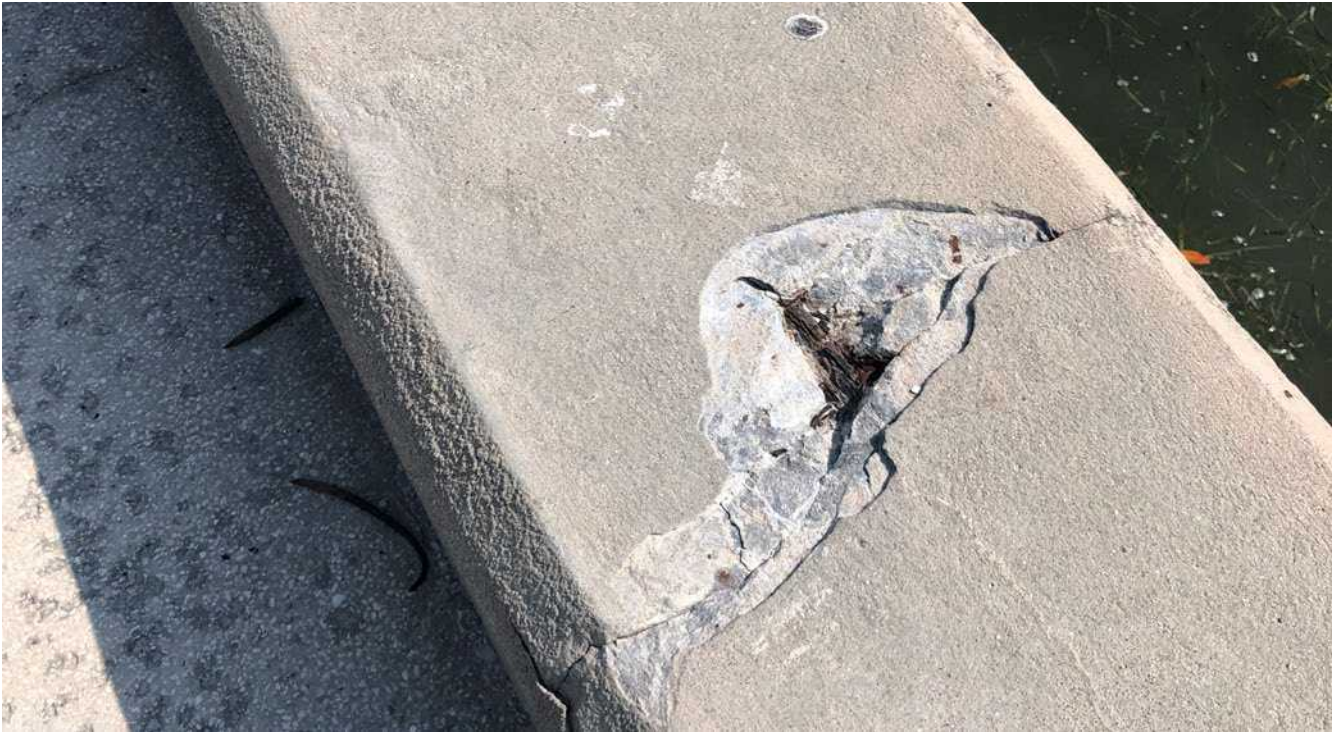
There are spalls throughout the cap, some severe. For most of the seawall, spalls are minor corner spalls with no exposed rebar or signs of underlying corrosion. There are also some previously repaired spalls that are showing signs of failure and may need to be repaired again.

**Figure 3-7 Spall with Exposed Rebar**

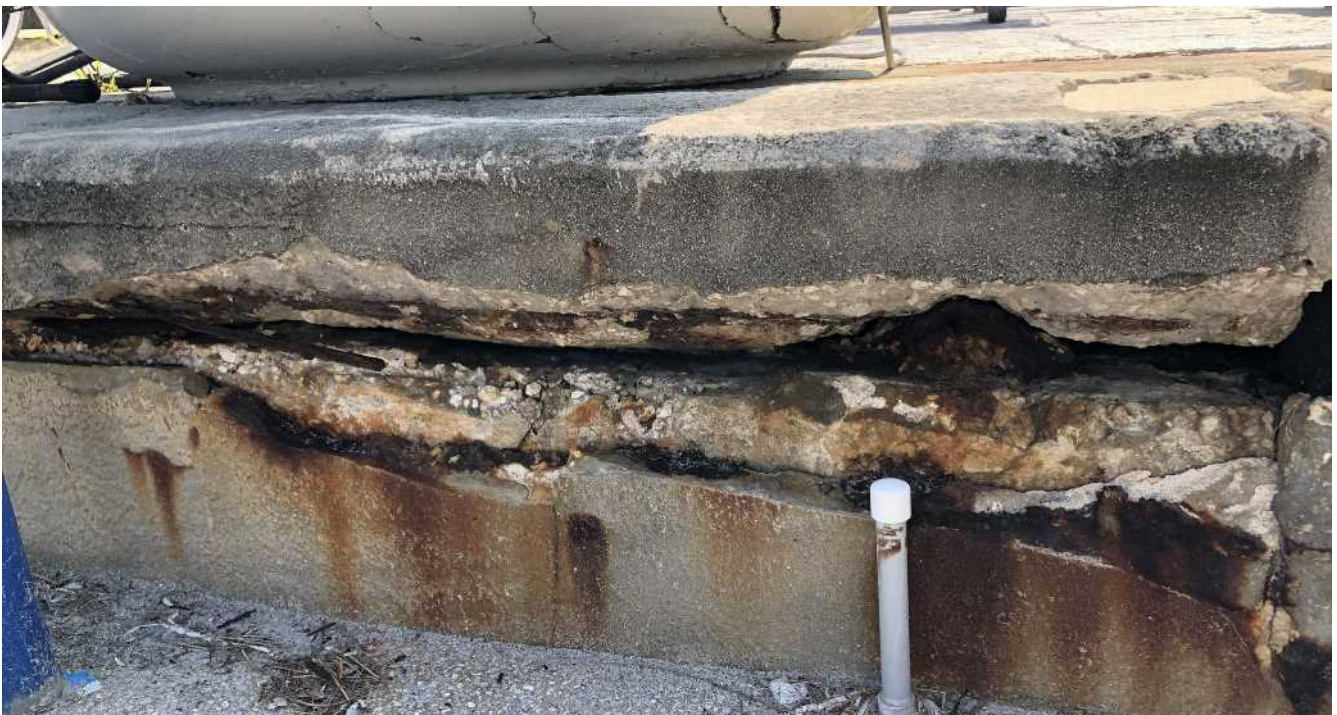
Beginning at station 17+00, major spalls with exposed rebar begin to appear. There are 3 locations between stations 17+00 and 18+00 of severe spalls with exposed rebar exhibiting more than 50% section loss. The cap at these locations is structurally deficient. There are also at least 2 locations with exposed rebar without severe section loss.

**Figure 3-8 Severe Spall, Exposed Rebar with Complete Section Loss**

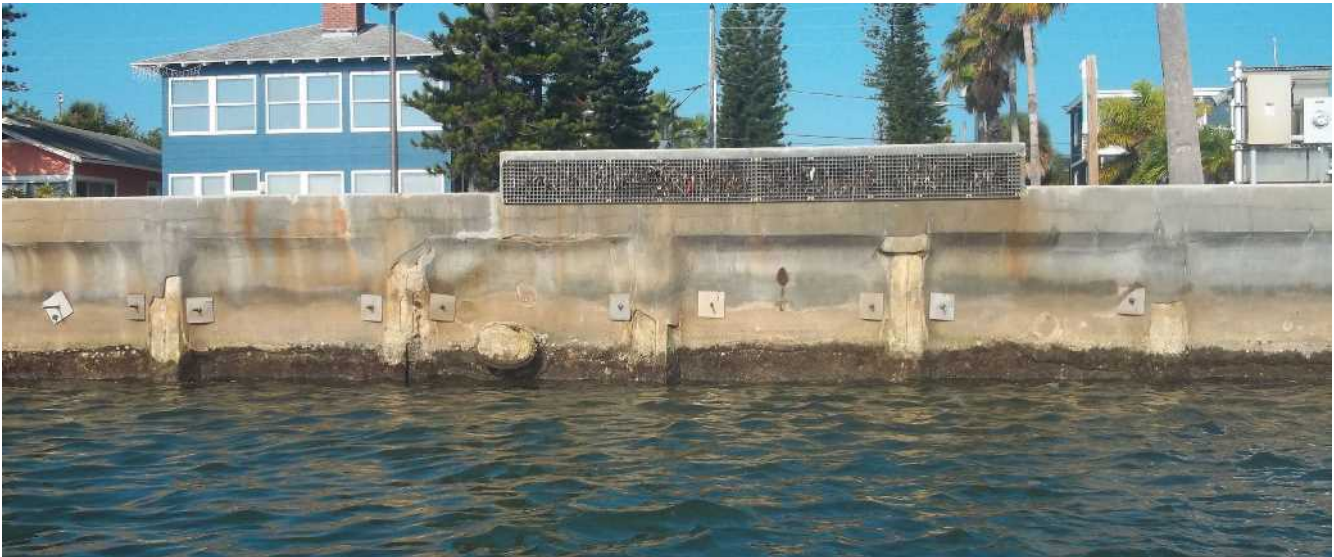
There are tiebacks between stations 5+00 and 6+00 that are not found in the rest of the wall. They are located at either side of the piles. They are in good condition. It is unclear if these tiebacks were installed with the rest of the wall or at a later date.

**Figure 3-9 Tiebacks Between Stations 5+00 and 6+00**

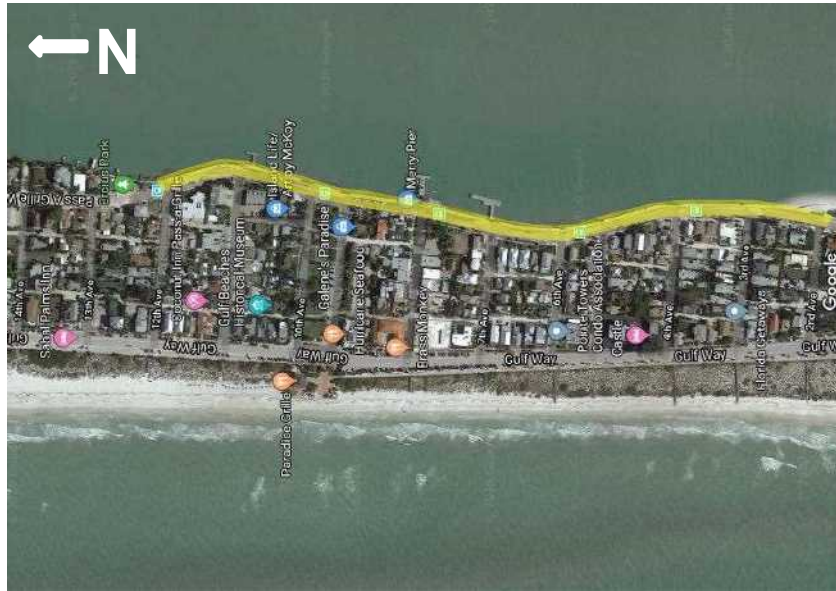
Figure 1: Overview of Pass-a-Grille Way

Pass-a-Grille Way is a roadway on the eastern side of Pass-a-Grille Beach, which is located in the city of St. Pete Beach, Florida. The roadway and sidewalk on the east side between 3<sup>rd</sup> Ave and 12<sup>th</sup> Ave are directly adjacent to the Pass-a-Grille Channel and are separated from the channel by a seawall. Drainage line installation in this area revealed the presence of voids below the roadway and sidewalk. Cardon, Inc. has reached out to Vector Corrosion Services (VCS) to conduct ground penetrating radar (GPR) scanning of the side walk and adjacent parking spaces in order to identify the possible presence of voids. The surveyed section of the Pass-a-Grille Way is highlighted in yellow in Figure 1.

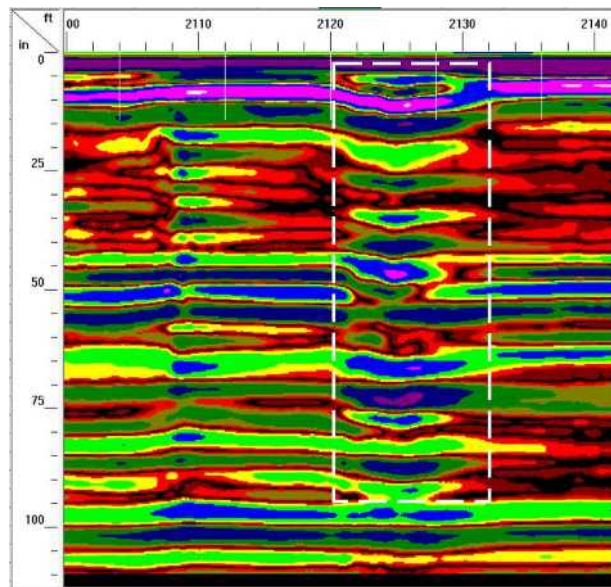
Type 1 anomalies are areas where the natural subsurface conditions have been disturbed. This usually occurs where fine soil materials (clays and silts) have washed or eroded away or may be areas that were filled with a coarser sand or gravel that allow moisture to drain.

Figure 2: Example of a Type 2 Anomaly in the Collected Data

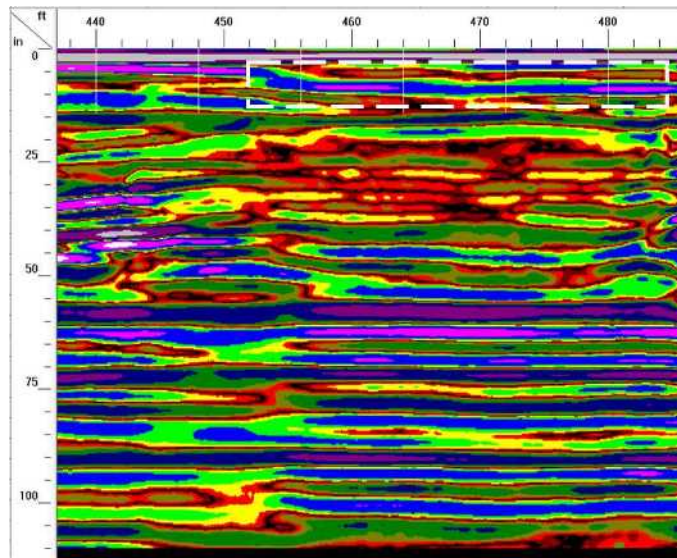
Type 2 anomalies are areas like Type 1 anomalies, but where the condition has “worked” its way towards the ground surface, indicating a high probability of a forming sink hole/voided area.

Figure 3: Example of a Type 2 Anomaly in the Collected Data

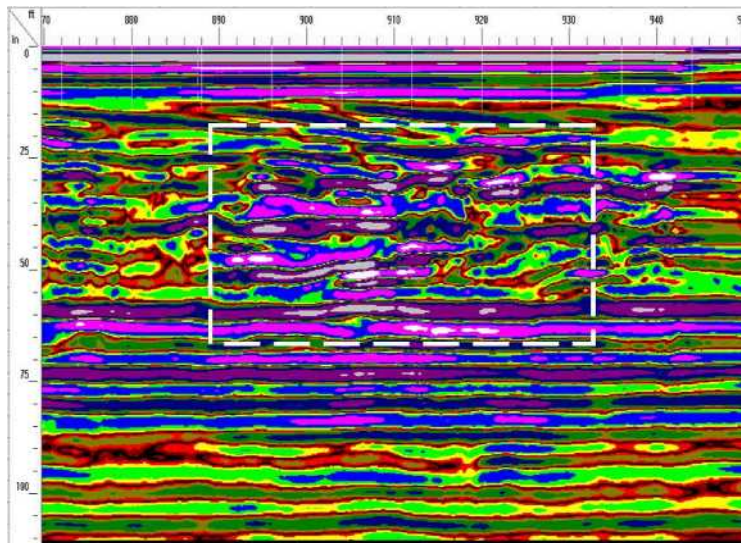
3. Type 3 – Areas of high conductivity/high moisture content relative to “normal” soil conditions  
 Type 3 anomalies are caused by more reflective soil conditions where moisture has accumulated, or may be areas where fine soils (silts and clays) have retained moisture.

Figure 4: Example of a Type 3 Anomaly in the Collected Data

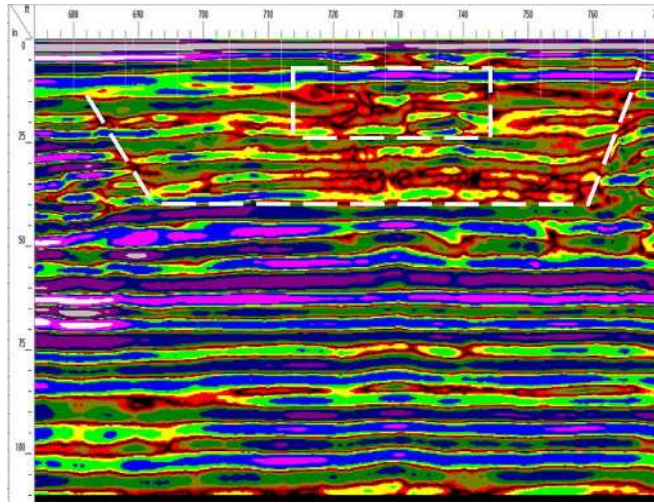
4. Type 4 – Areas where potential utilities have been installed, or previous reworking of natural soil conditions  
 Type 4 anomalies are areas where the ground has previously been reworked and the trench is visible in the data, these areas can be of concern when not properly filled leading to areas where the subsurface layering can turn into a Type 1 condition. It is important to note that filled utility trenches and old excavations may have similar GPR signal characteristics as developing or ancient filled sinkholes and/or areas of soil settlement.

Figure 5: Example of a Type 4 Anomaly in the Collected Data

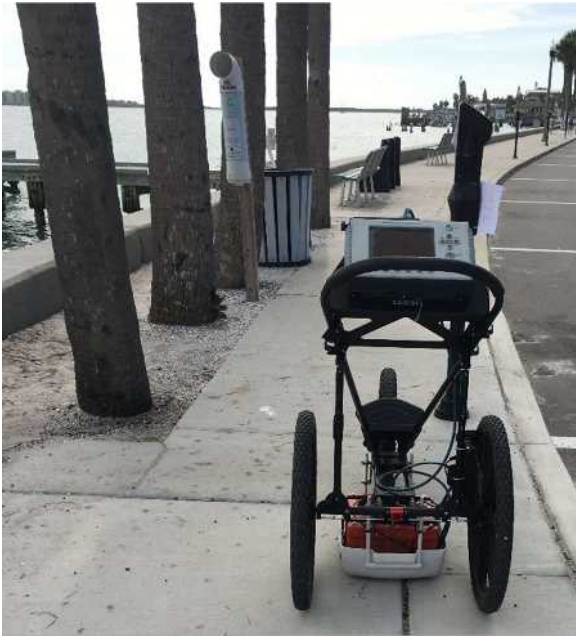
It should be noted that a large portion of the scan path directly against the seawall was obstructed by the trees and benches placed near the seawall (Figure 6). A void under the sidewalk tiles was observed on the north side of Merry Pier. The location of this void is circled in red in Figure 7, and the depth was of the void was approximately 11 inches below the top of the pavement. However, it was not possible to position the GPR cart over the void to obtain a scan due to the obstructions in the GPR path (electrical box on the north and stair steps on the south side). It looked like some settlement have occurred in the area around the void. The location of this void was added to Appendix B, although it was not possible to determine accurate dimensions for this void.

Figure 6: Path Next to the Seawall Obstructed by Trees and Benches

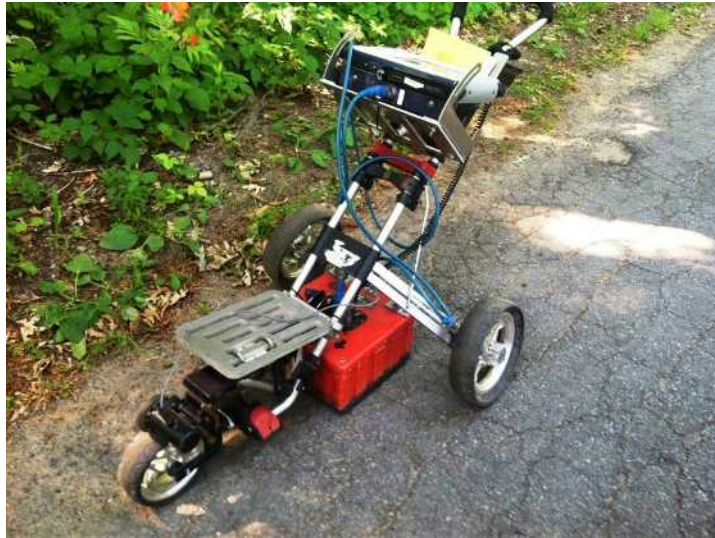
GPR systems consist of: Control unit (pulse transmitter, digital recorder, data storage, monitor); and an antenna(s) and survey wheel.

The GPR control unit is a computer which controls data acquisition parameters, such as sampling rate, range, gain control, filtering, etc. The Control Unit also visually displays the data, digitally archives the data, and allows for play back of the data.

Coaxial cable connects the control unit to the antenna. The antenna(s) are sealed and shielded in fiberglass housing.. Selection of the antenna is dictated by the requirements of the survey. For high resolution, near-surface data, a high frequency antenna is used; for deeper penetration investigation, a lower frequency antenna is used. Typically the 100 to 400 MHz antennas are used for geologic surveys; 400 to 900MHz are used for utility, near surface voiding settlement, foundation, etc surveys while the 900 to 1500 MHz are used for concrete reinforcing assessment.

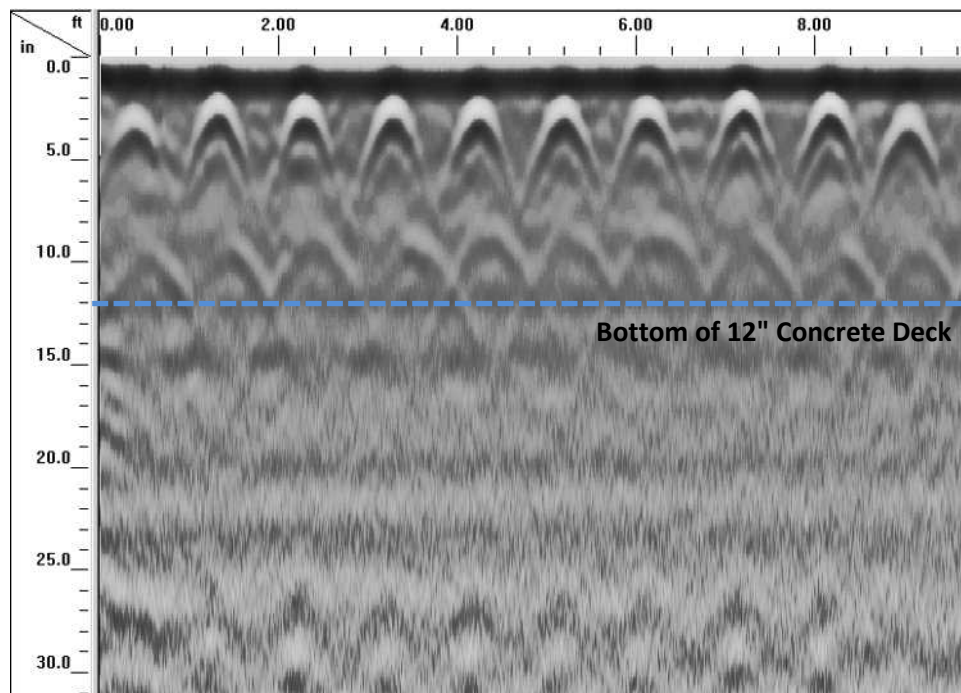
**Top Reinforcing**  
**12" spacing**  
**2+/- inches cover**

**Bottom Reinforcing**  
**12" spacing**  
**8-9 inches cover**

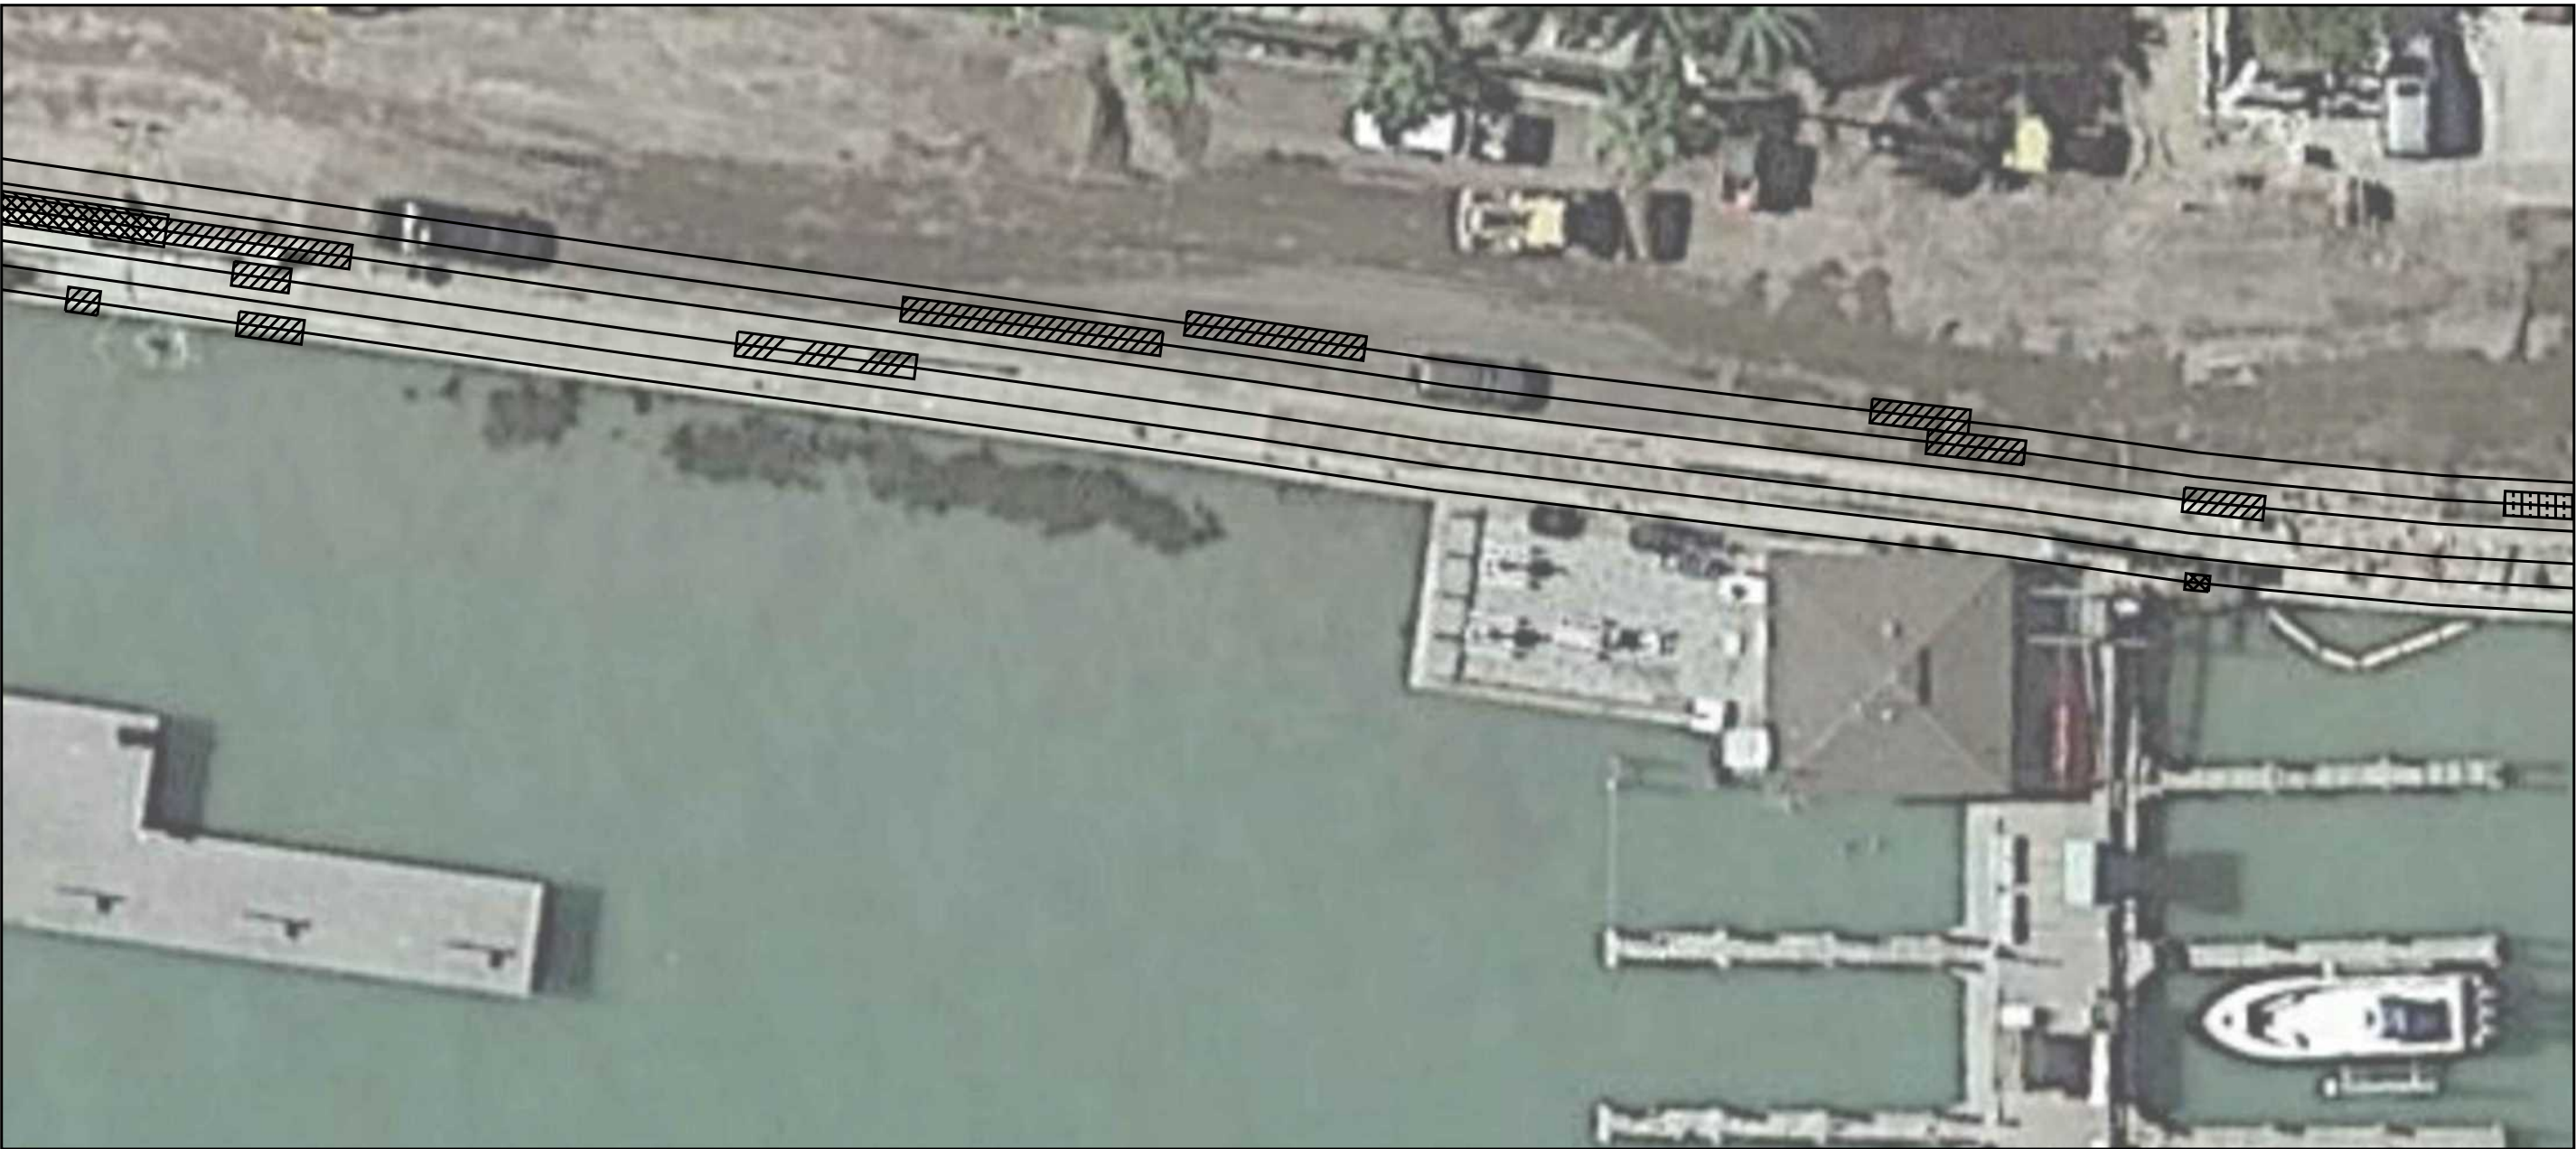
FIGURE 5

- PATH OF GPR MEASUREMENT
- [Diagonal hatching] TYPE 1: DRAPED/BROKEN LAYERS
- [Cross-hatching] TYPE 2: SHALLOW ANOMALY
- [Diagonal hatching, different angle] TYPE 3: HIGH MOISTURE
- [Vertical line pattern] TYPE 1/ TYPE 3: DRAPED/BROKEN LAYERS + MOISTURE
- [Diagonal hatching, different angle] TYPE 4: PREVIOUS REPAIR/ TRENCH

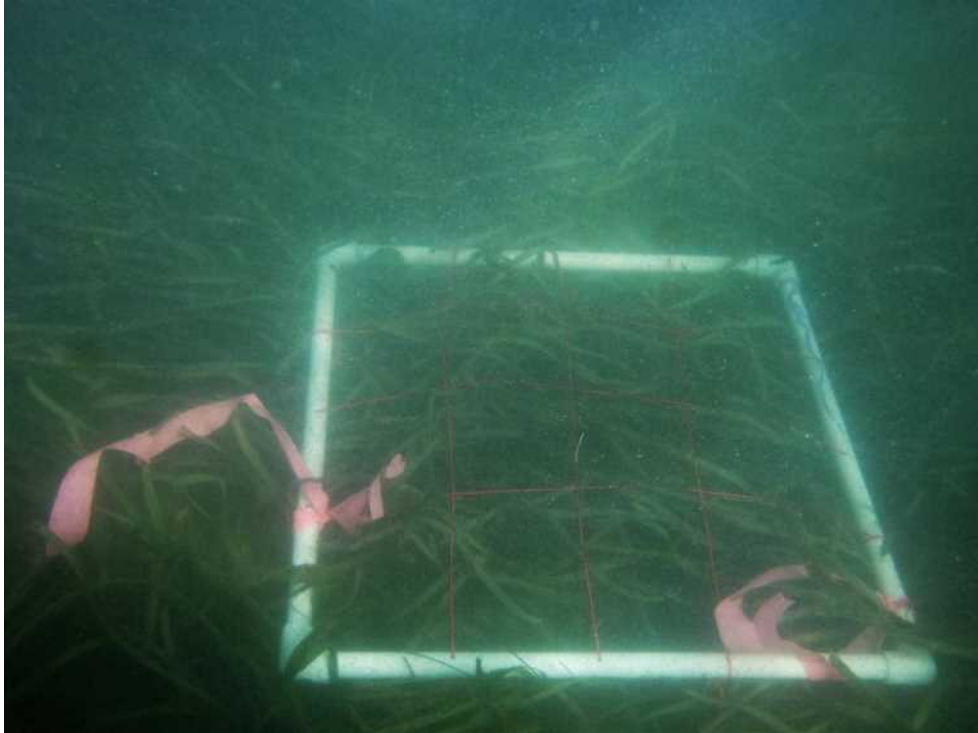
**Figure 5. Seagrasses within Project Boundary, Turtle Grass**

Aside from the southern-most third of the Project area, dense seagrass beds occupy the benthic substrate from the toe of the riprap/rubble to the seaward extent of the Project boundary, and into the channel. There are two distinct seagrass types. Turtle grass (*Thalassia testudinum*) (0.27 acres  $\pm$ ) dominates the northern half of the Project boundary, with a smaller section to the south (Figure 5). Between these two stretches of turtle grass, a section of manatee grass (*Syringodium filiforme*), dominated, while interspersed with turtle grass (0.09 acres  $\pm$ ). Additionally, various algae species such as attached Sargassum (*Sargassum sp.*), caulerpa (*Caulerpa mexicana*), and branched brown algae (*Dictyota sp.*) (Figure 6). Water depth at this location ranges from approximately 3 feet to 6 feet.

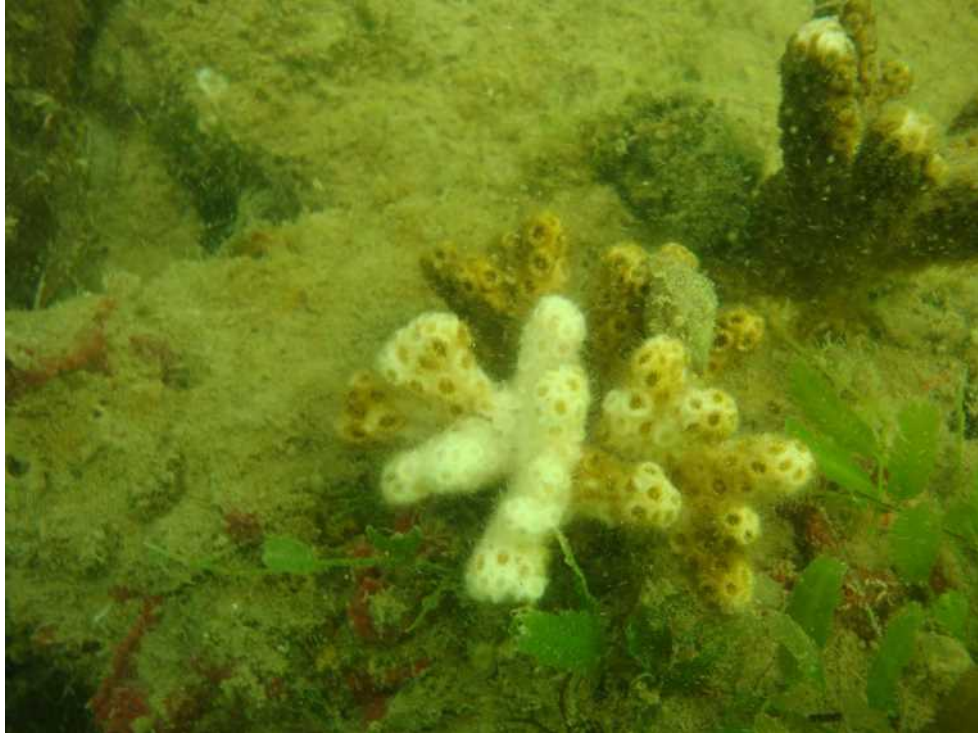
**Figure 7. Benthic fauna, Robust ivory coral, with caulerpa.**

The benthic fauna community occupies the southern-most third of the Project boundary. There is no natural hard bottom, but large riprap and debris have created substrate for benthic organism attachment. There is a clear delineation between where the seagrass community ends and the benthic faunal community begins. In this area, the bottom slopes to approximately 8 feet at the edge of the Project boundary. Larger pieces of riprap and rubble extend further from the seawall than in the northern extent. The attached and encrusting benthic community included robust ivory tree coral (*Oculina robusta*), colorful sea whip (*Leptogorgia virgulata*), boring sponge (*Cliona celata*), and other sponge and tunicate species (Figure 7). Sheepshead (*Archosargus probatocephalus*) and gray snapper (*Lutjanus griseus*) were observed utilizing the relief created by the rubble (Figure 8). Small schools of Atlantic bumper (*Chloroscombrus chrysurus*) were observed in the water column above the rubble and seagrass.
