## **CITY COMMISSION MEETING CITY OF ST. PETE BEACH**

Tuesday, January 26, 2021  
6:00 PM

**Summary of Issue:** During the reconstruction of Pass-a-Grille Way from 1<sup>st</sup> Avenue to 19<sup>th</sup> Avenue, the soil beneath the sidewalk adjacent to the seawall was found to be eroding away. This erosion prompted a Ground Penetrating Radar (GPR) study to evaluate the extent of the subsidence. The results of this study uncovered a substantial number of voids beneath the edge of the sidewalk immediately adjacent to the seawall.

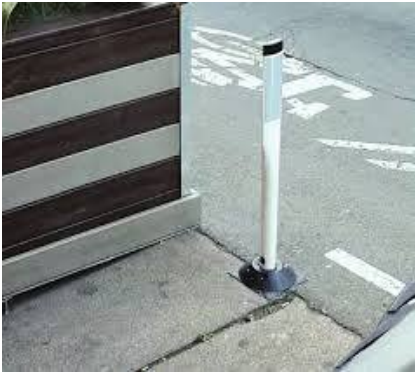
### Reflective Elements at Corners

Reflective elements are required at the outside corners of all parklets. Soft-hit posts are a standard solution deployed at the outside edges; however, the City will consider additional reflective elements incorporated in the parklet design.

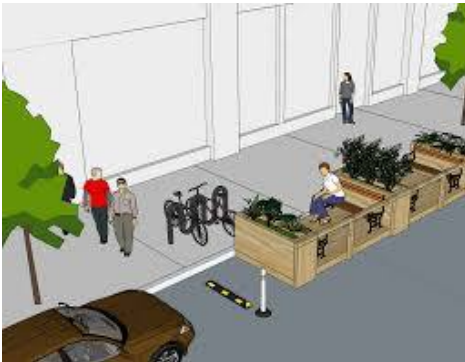
### Wheel Stops

For parklets in parallel parking spaces, a three-foot wheel stop must be installed one foot from the curb at the edge of the front and back parking spaces. When parklets are installed adjacent to parallel parking spaces, wheel stops should be setback four feet from the parklet structure. For angled parking spaces and adjacent to driveways, City staff will work with you to determine the appropriate location for wheel stops. Wheel stops shall be made of recycled rubber/plastic.
